# HOME INSPECTION REPORT

3456 Any Road  
Duncan, BC

November 27, 2005

## HARBOUR HOME INSPECTIONS, LTD.

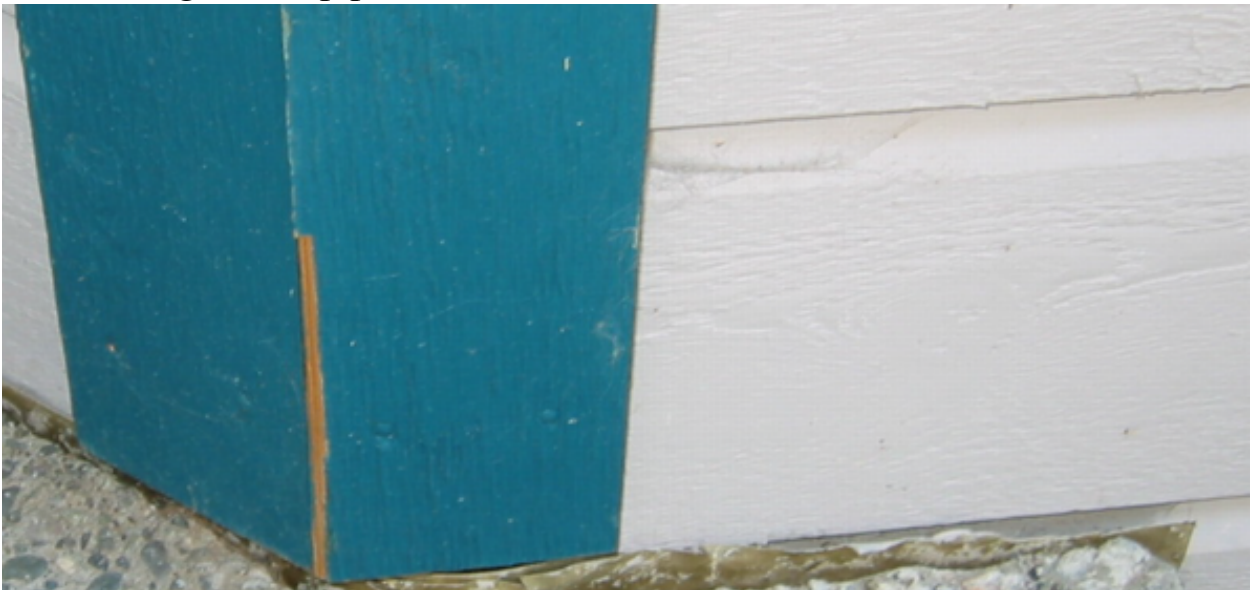
| ENTRY STEPS | |
|---|--|
| Condition | The metal flashing between the landing and the house should have a counterflashing or at least be caulked to prevent moisture entry. See photo.<br>A trim piece could be installed above the door area for appearance. |

Priority Items: Entry steps and ground clearance as noted. Caulking is also needed around the dryer and air intake vents at the back of the house; and around the gas inlet pipe.

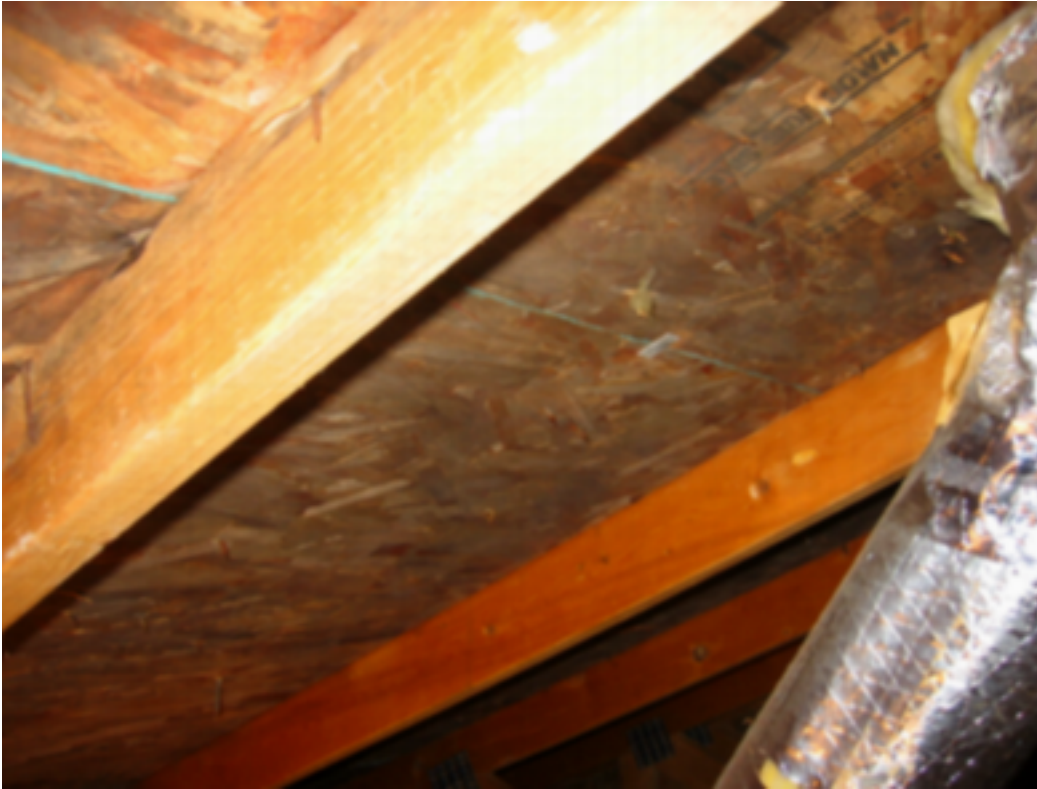
**Significant Issues:** There is mould in the flat ceiling section of the attic. There are no signs of leaks and I suspect the root cause of the mould is condensation from a lack of ventilation. The darkened wood and the rust on the protruding roofing nails extend over a wide area. Moisture readings taken in approximately ten places ranged from a safe 14% to a not so safe 20%.

Darkened areas indicate mould.

**The recommended course is professional examination and remediation.** Access should be cut into the attic area above the small bedroom. More soffit ventilation pans and roof vents should be added. Existing surfaces should be cleaned as best as possible and perhaps be sealed with a mould resistant paint. The attic access hatch should be weatherstripped to prevent warm air leakage. A mould problem is essentially a moisture problem. I could see portions of the chimneys from the flat ceiling section. Given the lack of firestopping in the mechanical room, this could also be a source of warm air leakage.

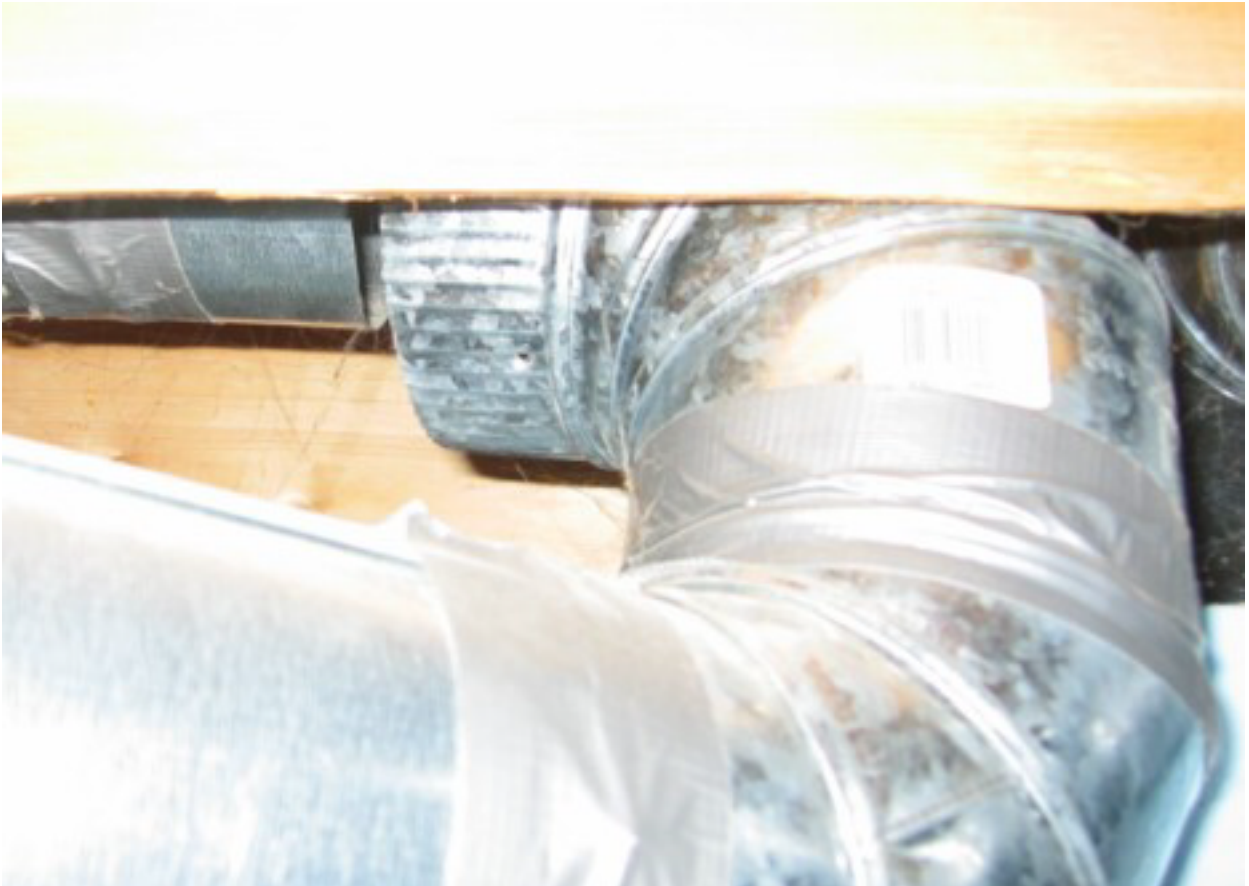
| Make-up air | To crawlspace above furnace-disconnected at foundation wall |

Priority Items: Connect noted air intake (see photo). Check to see if gas fireplace needs direct intake venting.
